## Serious Injury Accident: Mobile Equipment Accident June 2, 2004

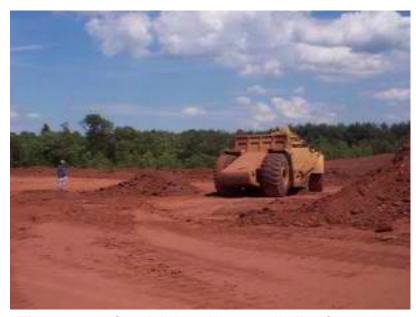
A mine contractor's heavy equipment operator was seriously injured when the loaded Caterpillar 621B scraper he was operating turned over while taking a right turn around a stockpile. The victim's left foot was slung out of the cab as the vehicle turned over and the forward portion of his foot was crushed between the cab-mounted grab rail and the ground. The victim was transported and admitted to a hospital for emergency surgery and, due to the severity of the injury, a portion of the victim's left foot had to be removed. The primary cause of the accident was determined to be very low air pressure in the left rear tire of the scraper (32 psi versus recommended 55-60 psi). Further investigation revealed that an o-ring seal was missing from the tire, which allowed air to leak. Contributing factors to the accident included the operator's lack of experience operating the scraper (only 1 week of experience) and rough road conditions. Although the victim had been task-trained, a written training plan was not available.

The scraper after righting. Note small pile of material that was dumped when the scraper turned over.

RECOMMENDATIONS: Equipment operators must inspect their equipment prior to use each shift, notify the certified mine foreman of any safety defects, and correct any safety or health defects before the equipment is used (4VAC25-40-145). Tire inflation should be monitored closely on all mobile equipment, and the equipment should be maintained according to the manufacturer's specifications (4VAC25-40-360). Roadways should be marked, maintained in a smooth condition, and posted with appropriate speed limits and traffic controls for the equipment being used (4VAC25-40-1390/1540). Task training for new equipment operators should follow a written plan and include an extended period of observation by the trainer to assure proper operation of the equipment (4VAC25-40-100).

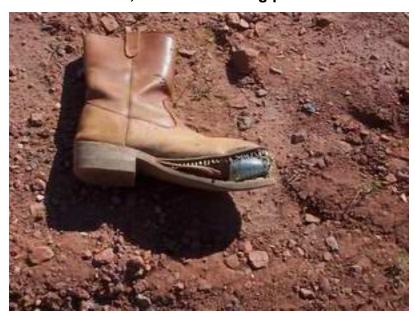
The injured miner's boot.
